**Stormwater Line Cleaning Report
for
Port of Seattle
Terminals 102, 103, 104, 106, 108, and 115**

IAA No. C1400216

IAA No.: C1400216
Version: FINAL
December 2015

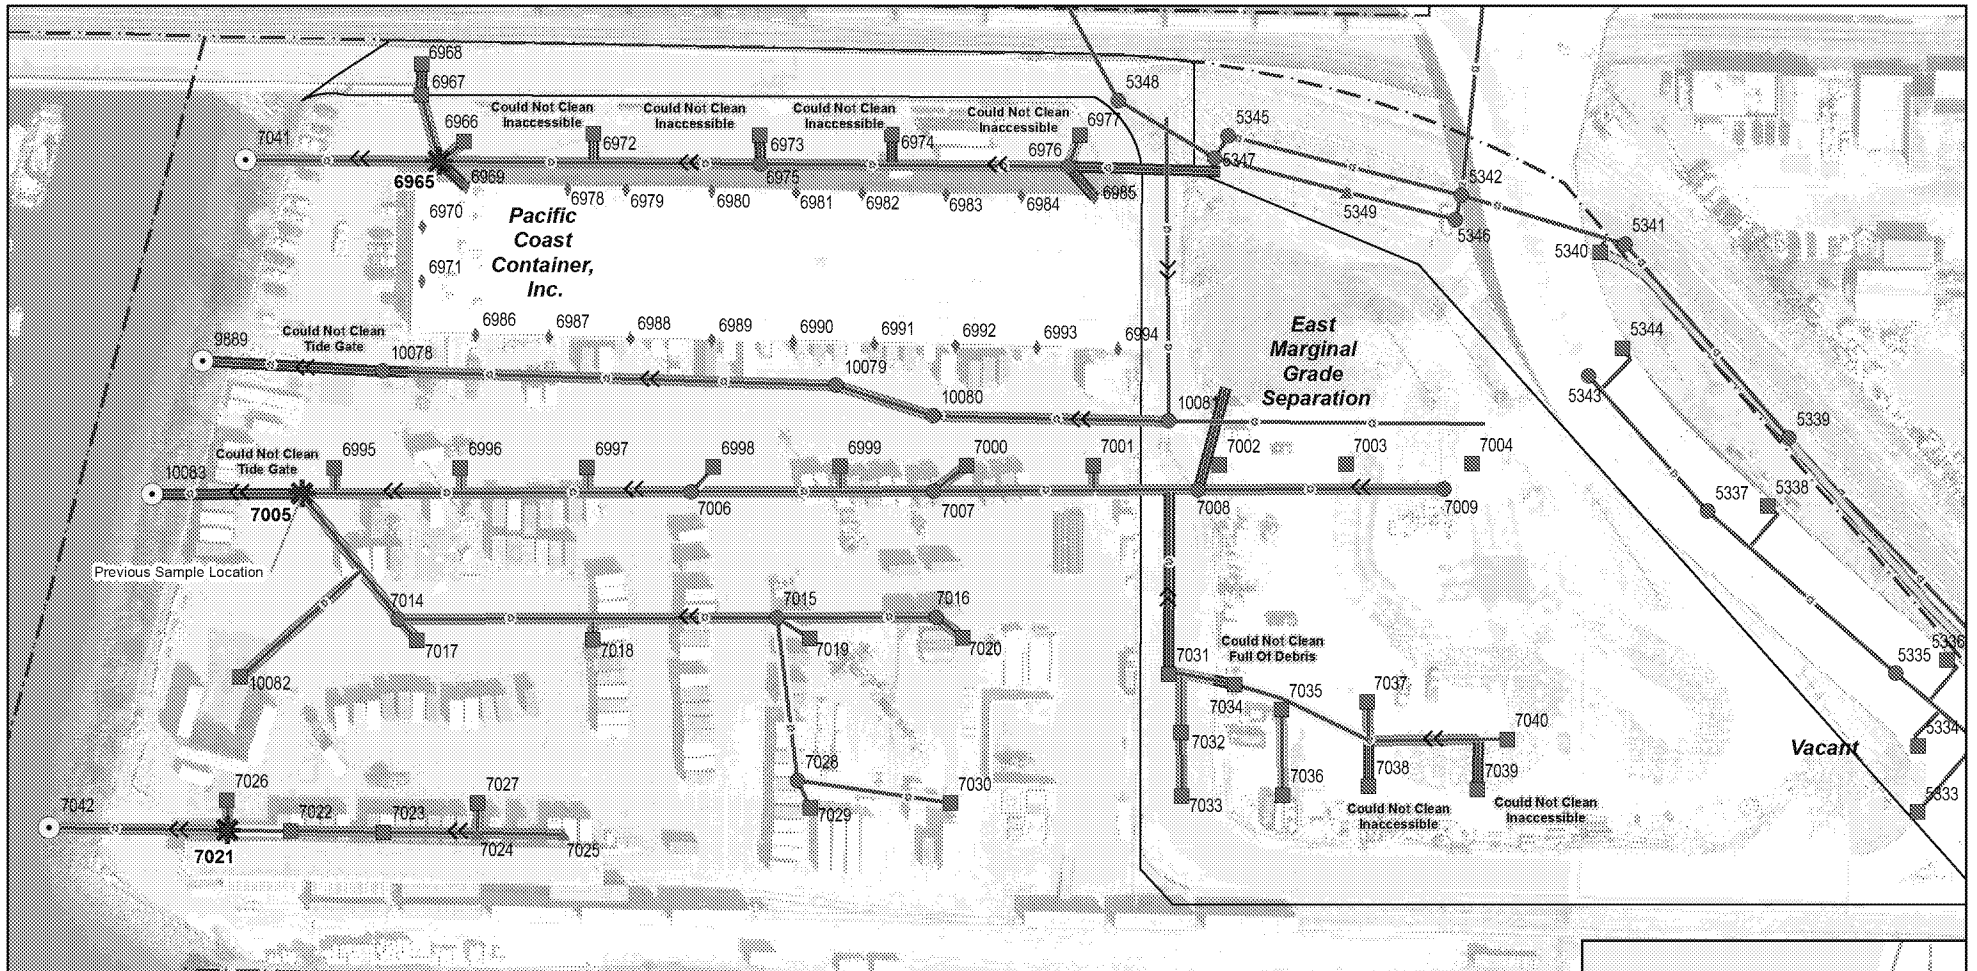
Figure 3
Terminal 104 Line Cleaning
Port of Seattle

Note: Figure adapted from information from the Port of Seattle. The original map was a compilation of Stormwater layers from the Port of Seattle CAD drawings (plans and as-builts), as well as notes from field visits (when possible).

Line cleaning was completed at Port Terminals 102, 103, 104, 106, 108, and 115 as shown on Figures 1 through 7. Storm lines that were accessible were cleaned, with the exception of Seattle Public Utilities lines on Port property. Line cleaning started in August 2014, and continued through April 2015. Dates of the line cleaning, the number of the manhole/catch basins, and length of lines cleaned per terminal are provided in Table 1. Line cleaning reports are provided in Appendix B.

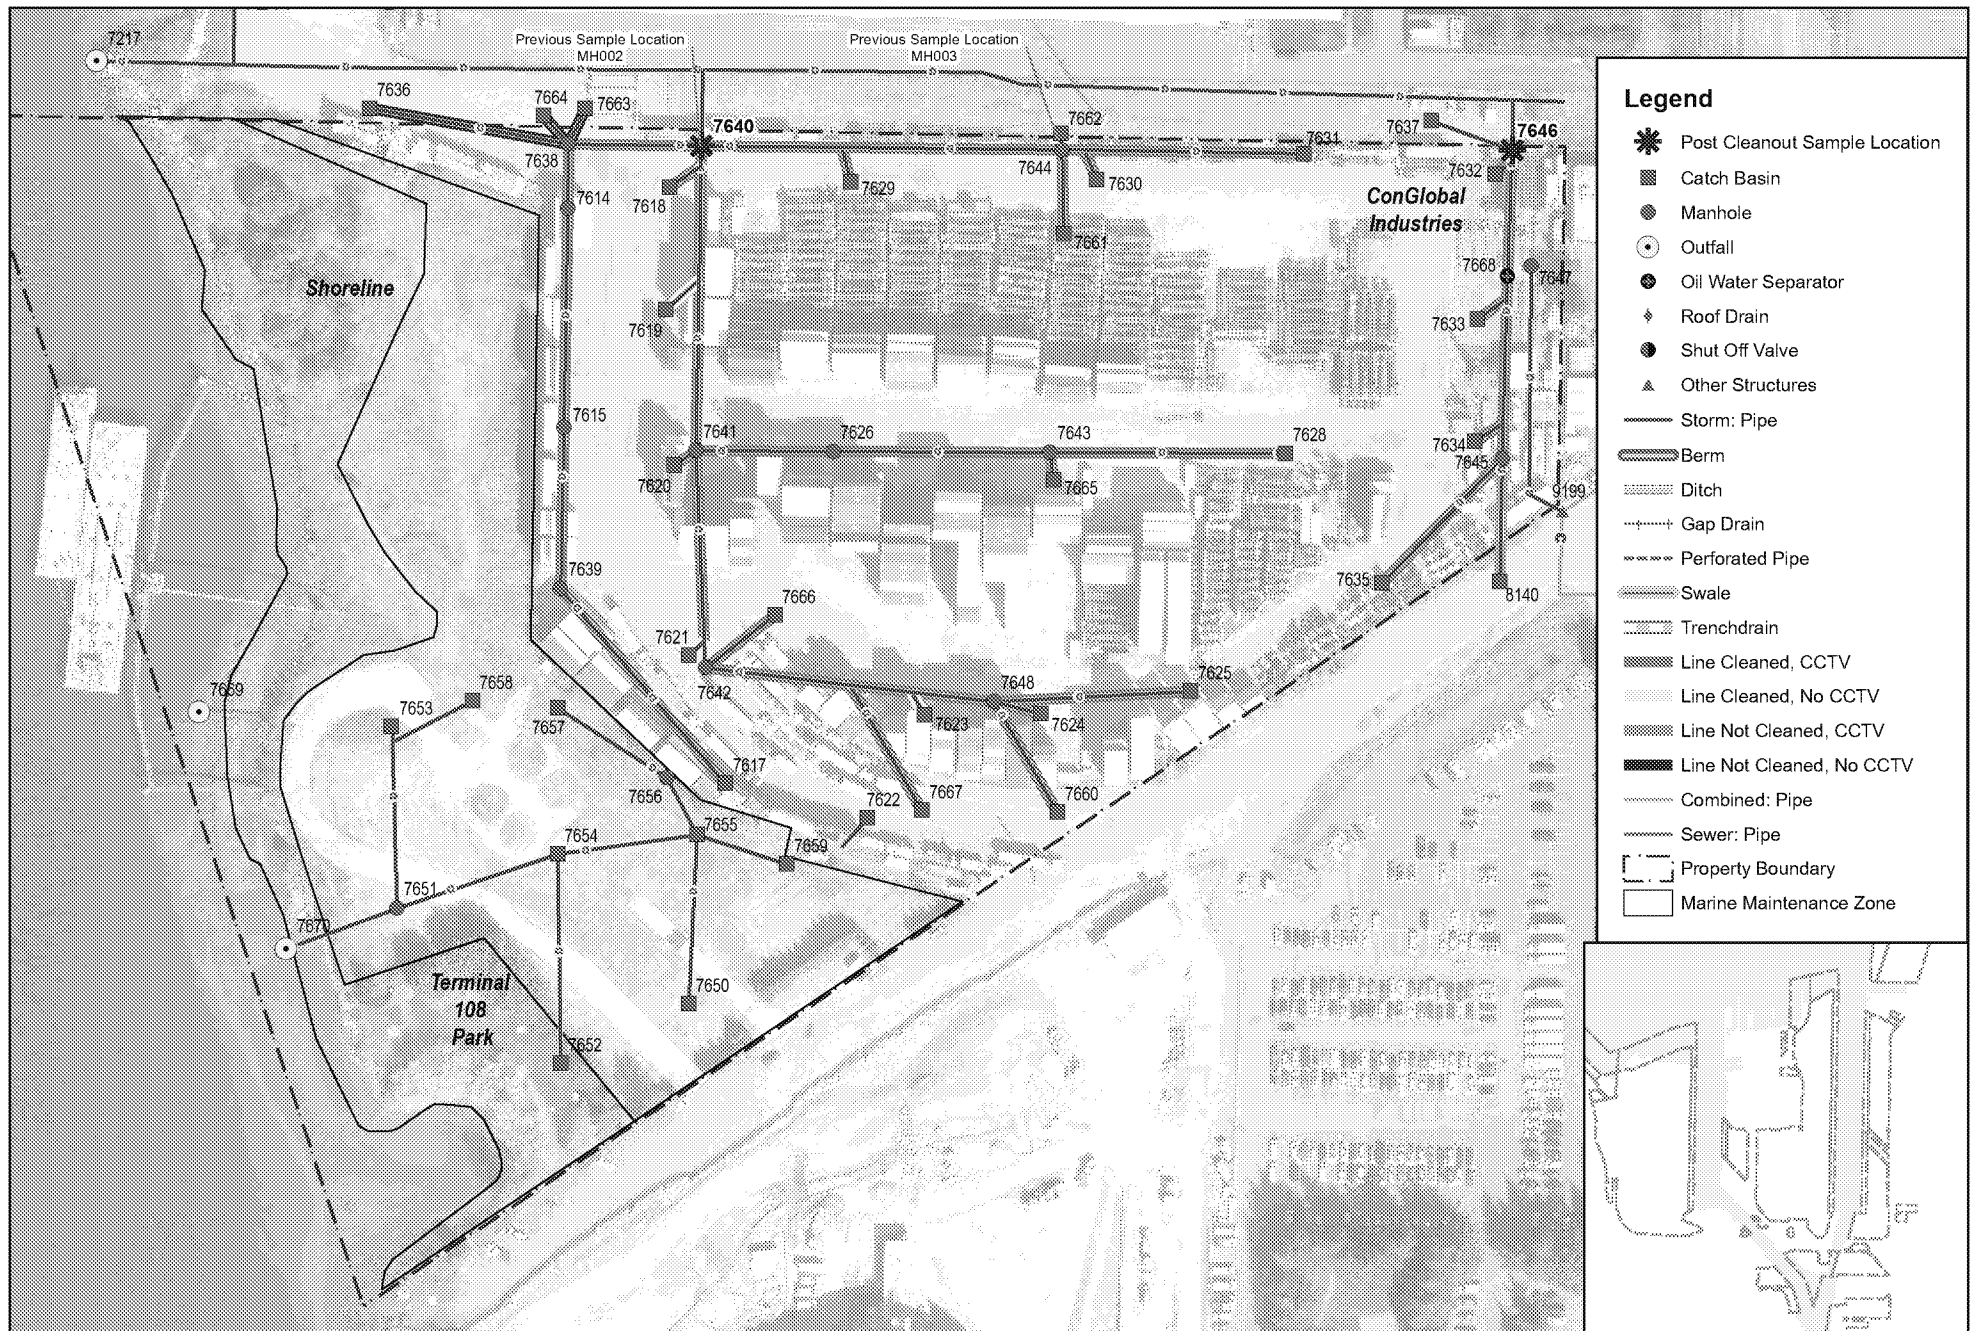
Figure 5
Terminal 108 Line Cleaning
Port of Seattle

Note: Figure adapted from information from the Port of Seattle. The original map was a compilation of Stormwater layers from the Port of Seattle CAD drawings (plans and as-builts), as well as notes from field visits (when possible).
